Manhole Inspection Summary

Manhole # S45A2_001MH

Location Address: **1327 E Patapsco Ave**

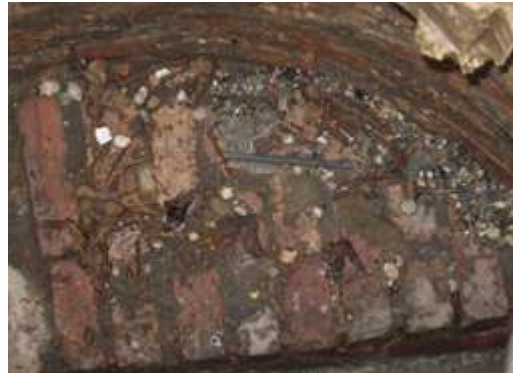
Defect 2

Debris

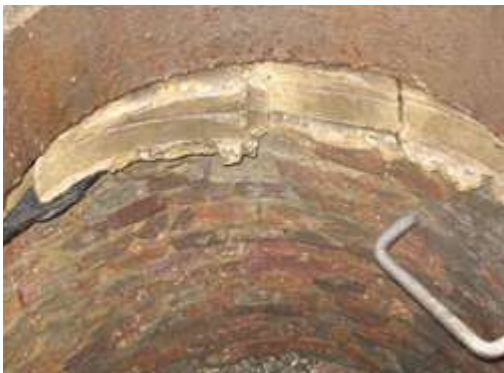
Defect 1

Condition: ☐ Sound ☒ **Cracked** ☐ Root Intrusion ☐ Loose Brick ☐ Deteriorated

Infiltration: ☐ None ☐ Joint ☒ **Cracks** ☐ Mortar ☐ Roots ☐ Wall

Cracks

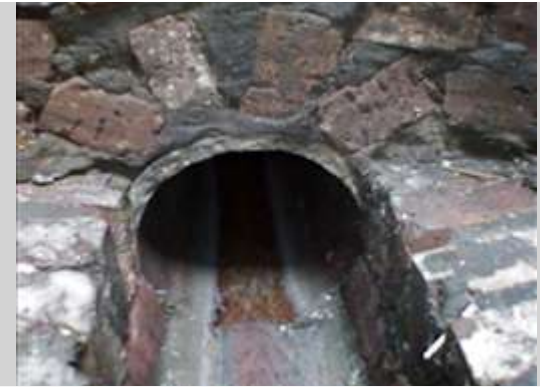
12 O'Clock Outflow

8 in. Circular Gravity Sewer
Pipe Out @ 12 O'Clock

Pipe Height: **9.6** (in.) Rod and Bar (Angled)
Pipe Material: **Clay** ☐ Pipe Lined
Invert Depth: **4.66** (ft.) Flow Characteristics: **Fast**
Deposits: ☒ None ☐ Mud ☐ Sludge ☐ Debris ☐ Grease
Silt Depth: (in.) Deposits Extent:
Infiltration: **None** Pipe Seal Cond: **Sound**

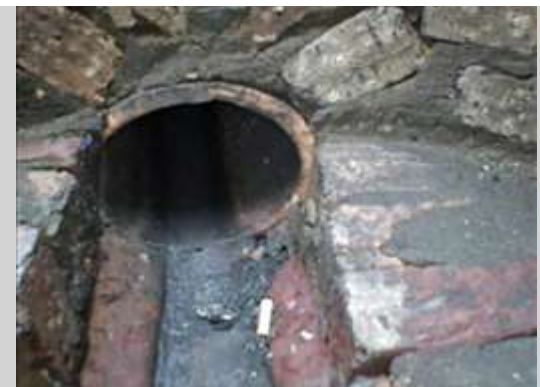
4 O'Clock Inflow

6 in. Circular Service Sewer
Pipe In @ 4 O'Clock

Pipe Height: **6** (in.) Rod and Bar (Angled)
Pipe Material: **Clay** ☐ Pipe Lined
Invert Depth: **3.98** (ft.) Flow Characteristics: **None**
Deposits: ☒ None ☐ Mud ☐ Sludge ☐ Debris ☐ Grease
Silt Depth: (in.) Deposits Extent:
Infiltration: **None** Pipe Seal Cond: **Sound**

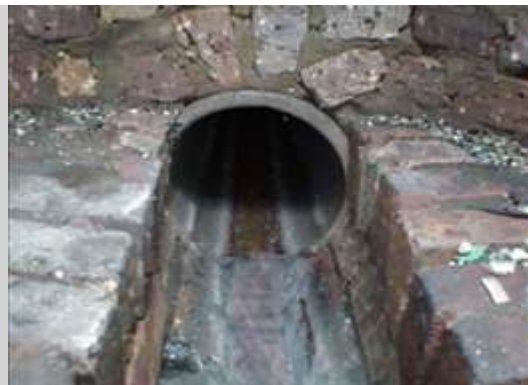
6 O'Clock Inflow

8 in. Circular Gravity Sewer
Pipe In @ 6 O'Clock

Pipe Height: **8.4** (in.) Rod and Bar (Angled)

Infiltration: **None** Pipe Seal Cond: **Sound**
